## NASA/TM-2014-218543

# Evaluation of the First Transport Rotorcraft Airframe Crash Testbed (TRACT 1) Full-Scale Crash Test

Martin S. Annett, Justin D. Littell, and Karen E. Jackson Langley Research Center, Hampton, Virginia

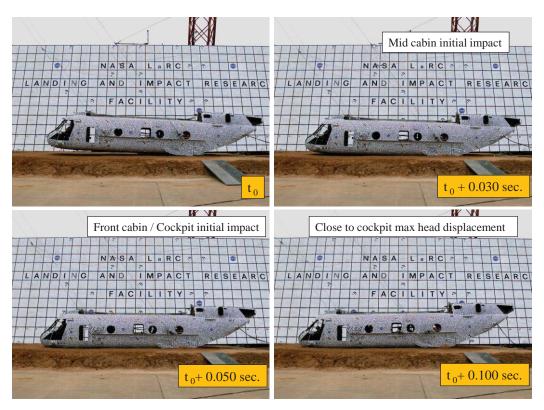
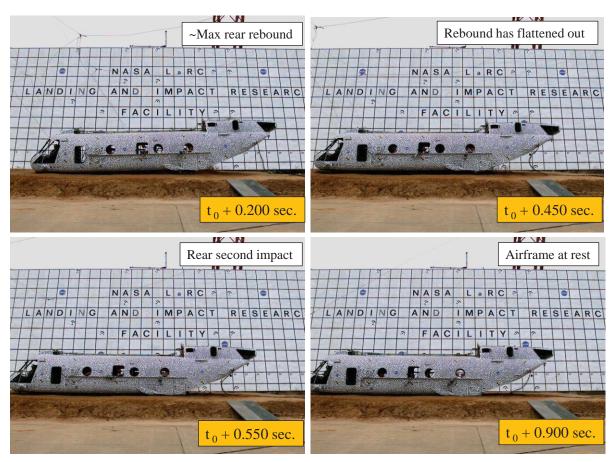
Photographs of the TRACT 1 airframe in the release position and just following impact are shown in Figure 26. All external and onboard high speed video cameras properly triggered and recorded data through the swing and impact phase. The actual impact conditions are listed in Table 7. A photo time lapse from an external high-speed camera is shown in Figure 27 and Figure 28. The airframe impacted the soft soil with a 2.5° nose-up pitch attitude, causing the aft frames to impact initially. Next, the airframe rotated allowing the forward cabin to impact the soil. The duration of the point of impact to cockpit contact was approximately 0.020-sec. At 0.1-sec, the helicopter rebounded slightly, while maintaining a slight nose-down pitch and rolling towards the starboard side. A secondary impact occurred at 0.55-seconds, and the test article came to rest at 0.9-sec. The test article slide out was 8 ft.

Figure 27. Impact sequence of TRACT I test- 0-0.200 seconds

Figure 28. Impact sequence of TRACT I test- 0.200-0.9 seconds

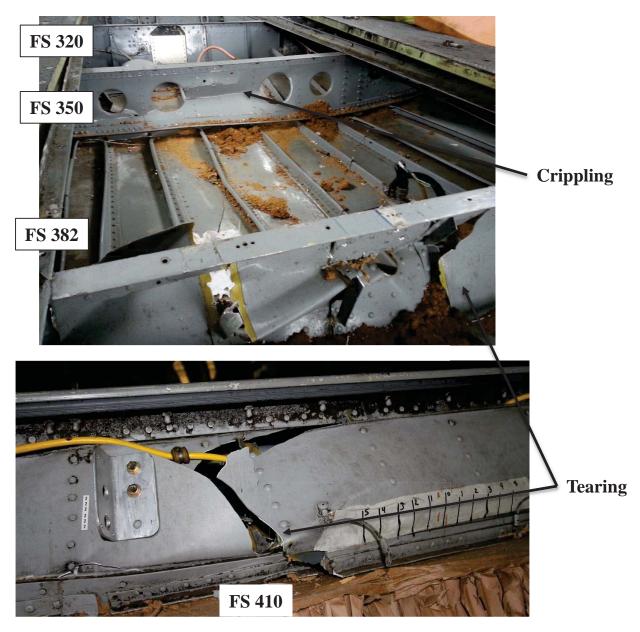
Structural damage to the helicopter was observed in the shear panels located beneath the floor at discrete FS locations. Damage to these panels was more severe near the rear of the aircraft, which is the location of first ground contact. The rear shear panel deformations from FS 320 to FS 410 are shown in Figure 29. Failure modes consisted of plastic deformation, crippling, and tearing. Minor deformation due to longitudinal shear was observed in the shear panels from FS 190 to FS 286 (Figure 30). In addition, some tearing of the material was noted adjacent to rivet lines between the outer skin and fuselage frames. Wrinkling of the outer skin was also observed, as shown in Figure 31, of the skin underneath the cockpit. Minor deformation was evident on the frame sections above the floor aft of FS 286. No damage was evident on the cabin floor.

Figure 29. Photograph illustrating failure in rear cabin shear panels

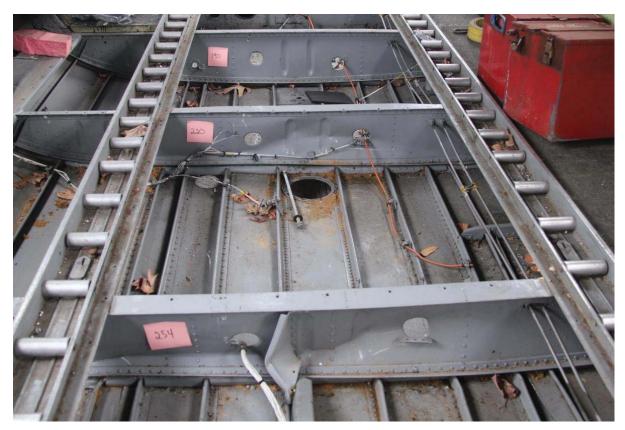
Figure 30. Photograph illustrating failure in mid-cabin shear panels

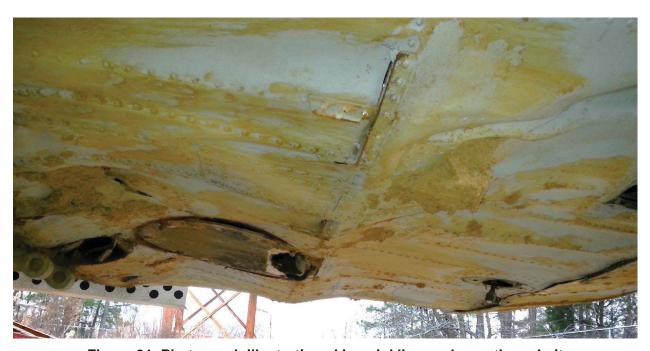
Figure 31. Photograph illustrating skin wrinkling underneath cockpit

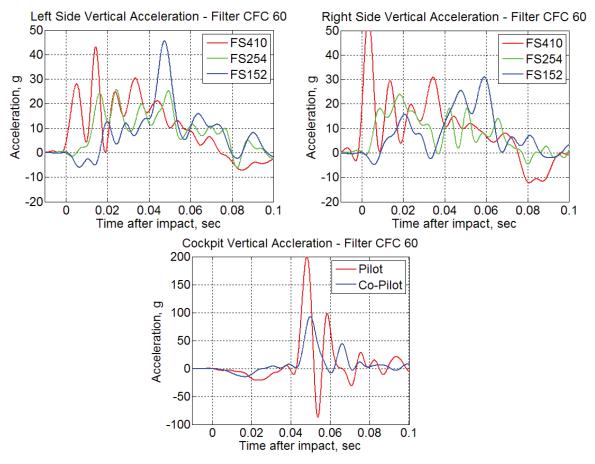
Figure 33. Vertical floor-level acceleration results for the left and right sides of the cabin and the cockpit

Given the nose-up pitch attitude at impact, it is expected that the onset of acceleration would occur first for FS 410, next for FS 254, and last from FS 152. The data shown in Figure 33 confirm this expectation. The left side acceleration responses range in peak magnitude between 25- and 45-g with durations of approximately 0.08 seconds. The right side responses range in peak magnitude between 22- and 55-g with a duration of approximately 0.08 seconds. The difference in responses between left and right are attributed to the seat m. At FS 152, there is a noticeable negative component of acceleration before 0.03 seconds as the test article pitches down. The behavior is more pronounced in the pilot and co-pilot responses. The co-pilot and pilot responses have very high magnitude oscillations after slam down at 0.04 seconds. There is a high different between the co-pilot and the pilot responses because of the locations of the accelerometer blocks on the thin-walled floor.

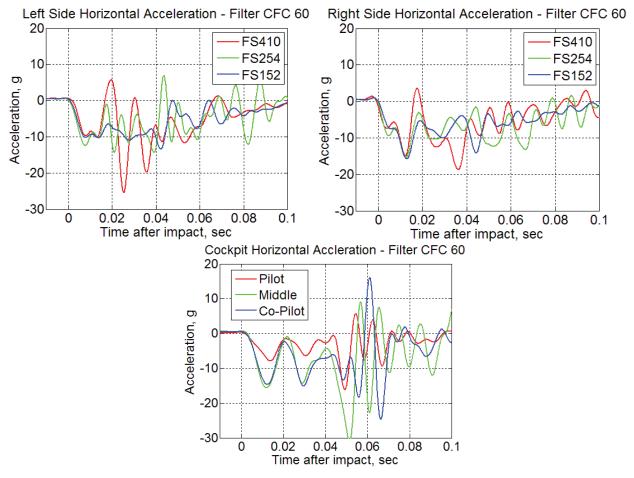
Figure 34. Horizontal floor-level acceleration responses

Horizontal acceleration time history responses are shown in Figure 34, along with a fuselage schematic showing instrumentation locations. Three plots are shown for the left and right sides of the airframe, and for the cockpit. Each of the curves shows a similar response, with average magnitudes of approximately 10-g. The entire aircraft begins to longitudinally decelerate within the first 0.005 seconds. The magnitude of the peak horizontal acceleration is approximately 30-g; however, most traces are lower.

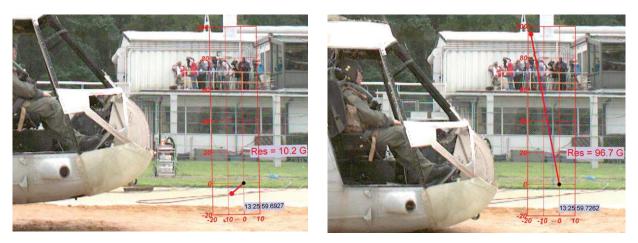
Figure 35. Cockpit resultant acceleration

The orientations and magnitudes of the resultant accelerations just before and after cockpit belly impact are illustrated in Figure 35. In Figure 35a, the orientation of the airframe deceleration is pointed to the aft and down. The pilot and co-pilot excursions are in the opposite direction, upward and forward. The magnitude of the negative component is approximately 10-g during nose over. In Figure 35b, after cockpit belly impact, the acceleration is directed up and slightly aft with a magnitude greater than 95-g.

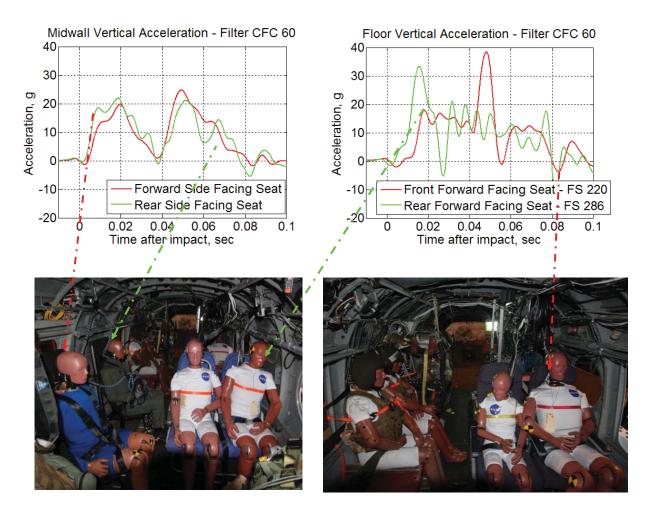
Figure 36. Cabin vertical acceleration responses at seat attachment locations

Cabin mid-wall and floor vertical acceleration responses are shown in Figure 36, along with photographs indicating the locations of instrumentation. The mid-wall traces indicate two peaks, the first having a magnitude of approximately 20-g and the second having a magnitude of 25-g. The floor traces are from the two pair of forward facing seats. Whereas the mid-wall traces were

very similar, the floor traces are opposite to one another. The forward seat exhibits a 15-g uniform acceleration response, which suddenly increases near the end of the pulse to a peak of 38-g. Conversely, the rear seat exhibits an initial peak of 34-g, which is reduced to a relatively uniform 15-g response that decays near the end of the pulse. Both responses have durations of approximately 0.08 seconds.

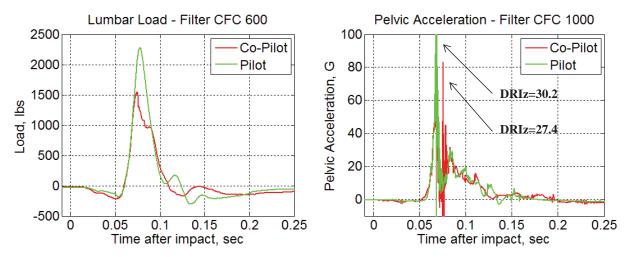
Figure 40. Pilot/Co-pilot ATD lumbar load and vertical pelvic acceleration

The seats vertical EAs begin to stroke at 0.080 seconds and the ATDs commence forward flail. Figure 40 shows the lumbar load filtered to SAE Class 600 and vertical pelvic acceleration filtered to SAE Class 1000. Peak lumbar load and vertical pelvic acceleration occur at the time of stroke. Post-test inspection of the seats indicated that the vertical and horizontal EAs stroked approximately 4 inches and 1.5 inches, respectively.

The pelvic acceleration waveforms track the lumbar load similarly. Magnitudes do not track linearly with lumbar load, with magnitude spikes above 70 g for the co-pilot and 100-g for the pilot. These abrupt peaks are caused by the ATD re-contacting the seat pan, and therefore not evident as the load path is damped into the lumbar. The relative velocities between the ATD and seat at the time of re-contact are different from the PARS retraction, causing different dynamic overshoot effects. These accelerations well exceed human acceleration tolerance limits for eyeballs down (+25 g) and would be categorized using Eiband curves as severe (ref. 17). The Dynamic Response Index in the spinal direction (DRIz) is 27.4 for the co-pilot and 30.2 for the pilot, indicating a >50% risk of AIS 2+ injury (ref. 18). These criteria are no longer recognized requirements, and have been superseded by lumbar criteria when evaluating crash loads specifically, but underscore the severe response of the pilot and co-pilot.

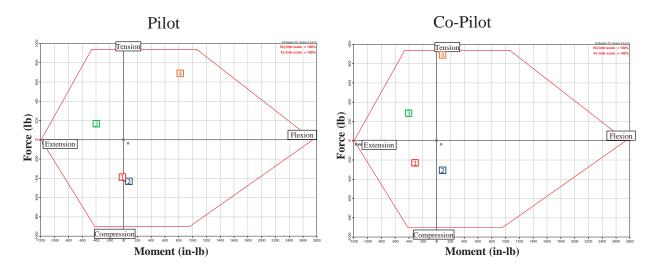
Figure 41. Pilot/ Co-pilot Nij

The potential for significant neck injury due to axial tension and compression and flexion and extension bending are evaluated by plotting the upper neck axial forces ( $F_z$ ) and moments ( $M_y$ ). Maximum neck flexion occurs at approximately 0.120 seconds. The Neck Injury Criteria (Nij) is used to determine the combined effect of axial and bending loads (ref. 19). Kite graphs showing the acceptable limits for force and moment are shown in Figure 41. The time of maximum axial load and bending loads often do not coincide, so Nij is computed for multiple instances during impact. Nij is calculated for four select times for both pilot and co-pilot. For the pilot, all forces and moments are within acceptable limits, while there is one case for the co-pilot where the axial tension is marginal.

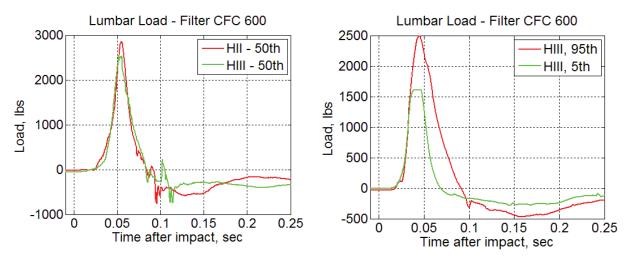
Figure 44. Forward facing ATDs, lumbar load

The lumbar loads are notably high for all four ATDs. Figure 44 shows the lumbar load for the 50<sup>th</sup> percentile ATDs. Load waveforms are similar in shape and duration, which is expected given the

similarity in hardware. The peak lumbar load was 2,900 lb. for the 50<sup>th</sup> FAA Hybrid III and 2,550 lb. for the 50<sup>th</sup> Hybrid II. The duration of the loading was approximately 0.060 seconds. These lumbar loads are well above the 1,500 lb. FAA limit, and would suggest a high likelihood of severe spinal injury. The peak lumbar load was approximately 1,600 lb. for the 5<sup>th</sup> Hybrid III and 2,500 lb. for the 95<sup>th</sup> Hybrid III. The lumbar load for the 5<sup>th</sup> female is an estimate from the waveform that appears to have saturated. This saturation is actually a scaling error identified post-test that limited the output range for that channel. The peak load of 1,600 lb. was determined through extrapolation. There is not a specific FAA requirement defined for the 5<sup>th</sup> and 95<sup>th</sup> ATDs. However, the DOD has recommended injury limits of 1,281 lb. for the 5<sup>th</sup> female and 2,534 lb. for the 95<sup>th</sup> male (ref. 14). The DOD recommendations for the 50<sup>th</sup> ATD are scaled up relative to the FAA requirement. Therefore, equivalent civilian requirements for the 5<sup>th</sup> and 95<sup>th</sup> would likely be lower. It is evident that lumbar loads for the 5<sup>th</sup> female and 95<sup>th</sup> male are near or above injury tolerance levels as well.

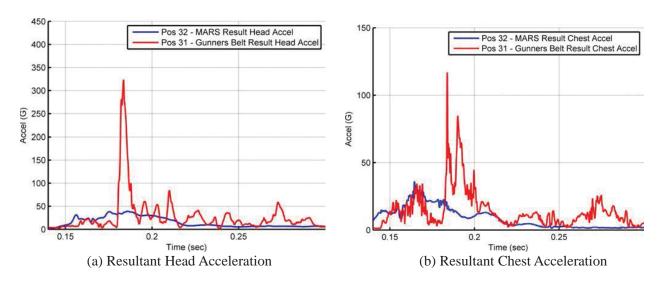
Figure 46. Resultant Acceleration for Mobile Aircrew ATDs

Figure 46a shows the resultant head acceleration time-histories for both ATDs. The head strike against the floor is clearly identifiable in the acceleration data. Both the magnitude and duration of this head strike are far in excess of human tolerance. With the MARS unit, the strike was prevented and head accelerations are substantially lower and sustained over a much longer duration. Head acceleration measurements indicate the head impact for the ATD with the gunner's belt was a lethal impact. The calculated Head Injury Criterion (HIC) for the gunner's belt ATD was 4,539. Correspondingly, the HIC for the MARS ATD was 248. For reference, HIC values of 1,000 are used as an injury threshold for frontal automotive crash certification, FAA seat performance standards, and Navy qualification test requirements. Figure 46b contains resultant chest acceleration time-histories for the two ATD's. Based on the typical 60-g critical chest acceleration limit, there is again an injurious situation with the gunner's belt ATD and a non-injurious situation with the MARS ATD. Figure 47 shows measured neck forces and moments. Key in these graphs is the remarkable difference between the two ATD's. For all neck forces and moments, the ATD with the MARS experienced less severe loading.

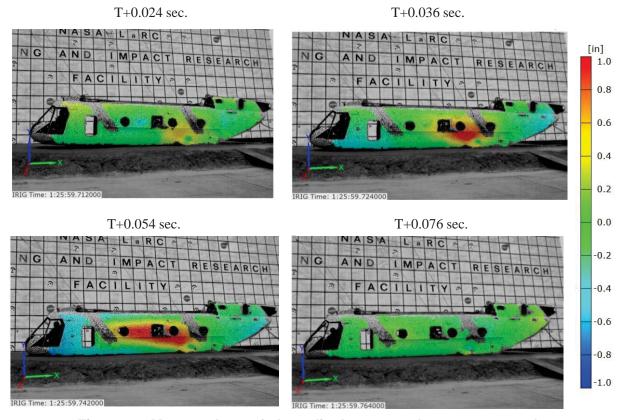
Figure 48. Measured out of plane displacement photogrammetry data

The exterior photogrammetry data was captured and analyzed post-test. Data was computed such that a data point was acquired every 1.5 inches over the entire port side skin of the test article, with over 8,000 data points acquired. A sequence of photogrammetry data that were collected during the crash test is shown in Figure 48. The diagonal regions in which no data are shown are attributed to exterior cables, which obscure the dots.

This displacement starts near the stub wing when this location comes in contact with the ground. As the point of impact of the test article moves forward during the impact, the computed out of plane motion also moves forward. These plots indicate flexing of the fuselage upon impact with the maximum out-of-plane (z) displacement of greater than 1 inch seen in the region of the middle round window above the swing beam between FS 286.0 and 320.0. Finally, the photogrammetric data show areas of permanent deformation around the stub wing locations and lower parts of the skin, near the floor. These locations match areas of damage seen in the fuselage post-test inspections taking the form of skin wrinkling and buckling. Figure 49 shows the discrete time histories of the out-of-plane points at WL +13. These points are interrogated further because the WL +13 points have the highest-on-average out-of-plane displacement. Figure 49 also shows vertical displacements taken from these same points at WL +44, which are the highest-on-average vertical values. These plots, taken together, suggest approximately 0.050 seconds after the impact shows the greatest fuselage deformation.

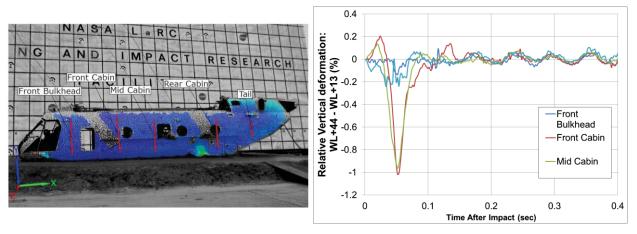
Further evidence of this flexing is demonstrated in Figure 50. Vertical relative deformation is evaluated by interrogating relative position change between discrete points along the length of the cabin at the frame locations. Five locations were investigated further using this technique. The analysis calculates the maximum change in length of a created line endpoint positions, divided by the original undeformed line length, and reported as a percentage similar to strain calculations. The maximum relative deformation occurs in the front and mid cabin suggesting that the largest unsupported test article locations are those with the highest deformation.

Figure 50. Relative vertical deformation photogrammetry data

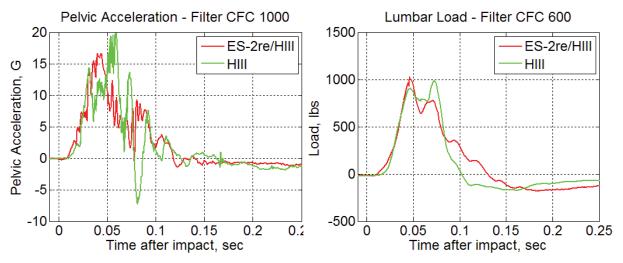
Figure 52. Side facing ATDs on CACS, pelvic acceleration and lumbar load (HIII offset by 0.010 seconds)

Lumbar load and vertical pelvic acceleration are plotted in Figure 52. Examination of the midwall acceleration near each seat (Figure 36) indicates that the aft seat was loaded just prior to the forward seat. If the lumbar load data is overlaid with this time difference removed (a 0.010 second phase shift), it becomes apparent that the onset rate and overall response are very similar. The lumbar load peaked at approximately 1,000 lb. for both ATDs, and pelvic acceleration were limited to roughly 20 g. These loads are regarded as moderate in severity. The total stroke for each CACS seat was noticeably different. The seat with the ES-2re ATD stroked 4 inches and the seat with the Hybrid III ATD stroked 1.2 inches. The load drop exhibited in both cases is evidence that some energy was absorbed by both seats. The larger force drop in the forward seat correlates to the longer stroke observed. The difference in seat stroke may be related to factors such as the loading and unloading behavior of the ATDs, variability in the stroking force produced by each seat's energy absorbers, or interaction with the standing ATD that had moved back against the forward seat occupant after release. Of note is that both seats limited spinal loads (as intended) even though the vertical component of the acceleration pulse applied to them at the sidewall interface was very

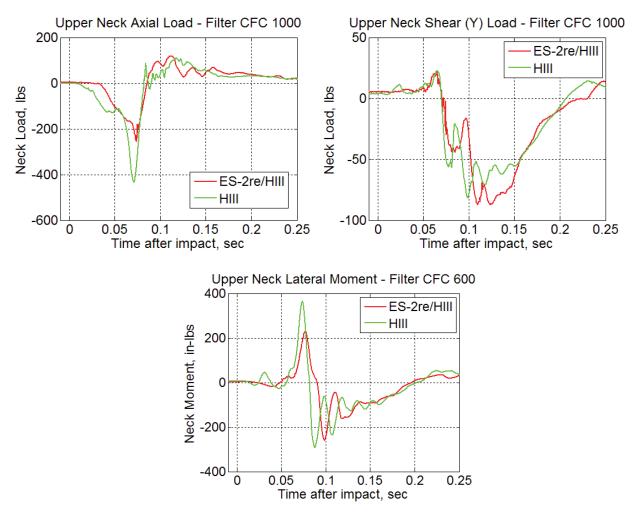
Figure 54. Side facing ATDs on CACS, upper neck forces and moments

The differences in stiffness for the ES-2re and Hybrid III necks are evident when comparing ATD upper neck forces and moments, as seen in Figure 54. Axial force and lateral bending moments were 50% lower for the ES-2re neck than the Hybrid III neck. The all of the loads measured at the ES-2re upper neck were well below the force and moment limits cited in the side-facing occupant neck injury criteria recently established by the FAA. These criteria include 405 lb. tension and compression, 185 lb. lateral shear, and 1,018 in-lb. lateral bending moment.

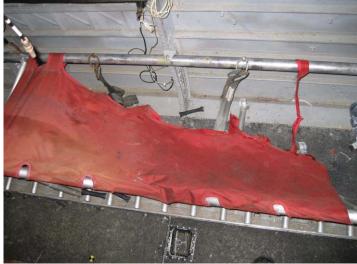
The high definition camera aimed at the Hybrid II ATDs on the CH-46 troop bench shifted during impact, and was unable to capture video coverage of the ATD motion. Post-test photos (Figure 55) showed that the seat fabric was torn off the aft frame, the front frame buckled near its center, and the right frame member detached from the aft frame. Because of the seat collapse, evaluation of lumbar load for injury is not appropriate, with more upper leg contact forces than pelvic. The ATD pelvises and upper legs were wedged within the frames, indicating a high likelihood of upper leg injury. Abdominal injury was also possible since the lap belt angle changed.

Figure 55. Side Facing ATDs on troop bench

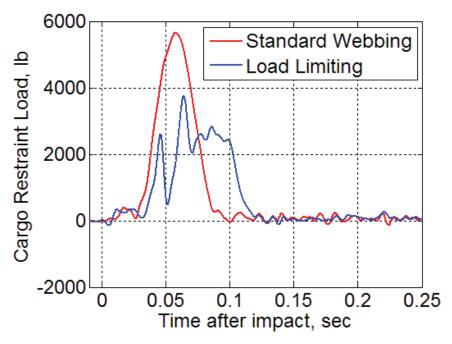
Figure 58. Cargo Restraint Load

Results for restraint forces in the standard webbing cargo restraint and the load-limiting cargo restraint are shown in Figure 58. The standard webbing cargo restraint developed a tensile load of nearly 5,000 lb. However, there was not enough kinetic energy in the cargo mass for the standard webbing to exceed the breakaway fitting load. The cargo mass was also decelerating in the vertical and longitudinal directions, which differs from typical sled test evaluations. The mass on the standard cargo restraint came to rest without severing the fitting, within 0.060 seconds. The load-limiting cargo restraint exhibited load-limiting behavior about the design load of 3,000 lb. The tensile force plot revealed a loading and unloading behavior as the strap sections ripped and unfolded. The duration of the deceleration was extended to greater than 0.100 seconds.

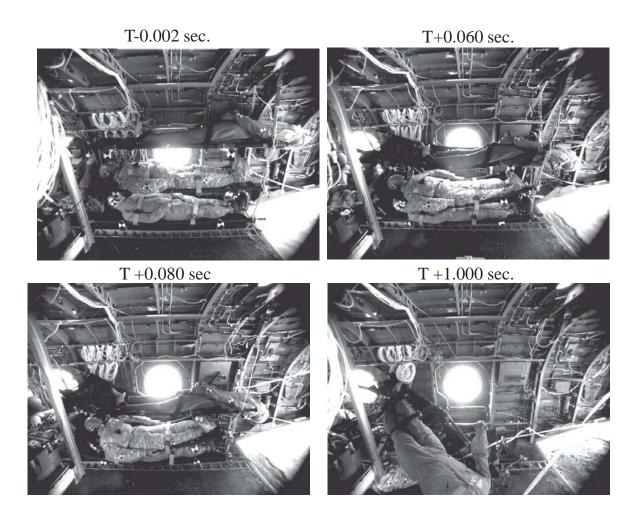
Figure 59. Patient Litter Sequence

A sequence of images from the high speed camera aimed at the patient litter is shown in Figure 59. During the swing phase, the unloading of the tie-down straps from freefall allowed the upper manikin to shift. The manikin's head was partially suspended off the edge at impact. The manikin and ATD in the middle and lower litter did not move, since the tie-down straps remained in contact with the lower torso. At T+0.060 seconds, there was considerable deformation in the litter covers and longitudinal litter tubes. At T+0.080 seconds, the ceiling mounted strap that supports the aft inboard corner of the upper litter frame detached at the frame, and the litter stack up collapsed. The upper manikin's head impacted the floor and rotated inward and forward with his legs still held with the tie-down straps. The middle ATD fell onto the lower manikin, and flailed freely forward after slackening of the tie-down straps. The lower manikin is impacted by the middle ATD and only shifted slightly forward. Severe injury is likely for all three ATDs.
